Volume V

Appendix G.12

Crew Survivability

Crew Survivability Report

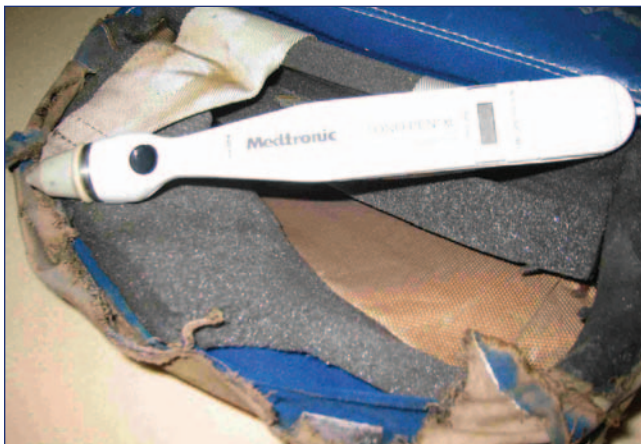
Figure 2.

Approximately 45% of the original crew module mass was recovered. Some major structural elements recovered, included portions of the forward and aft crew module bulkheads, window frames, mid-deck floor components, airlock and hatches. About 70% of the flight deck panels, and 80% of the mid-deck floor were recovered. Less than 20% of locker metal structure and fragments of the plastic and composite material of the locker trays were recovered. The Mid-deck Access Rack (MAR) was found nearly intact. Although some foam, fabric and paper were recovered, the bulk of the items recovered consisted of metal, plastic and composite materials. It is estimated that less than 30% of items stowed in the lockers were recovered. The EVA tool and suit debris (stowed mostly in the airlock for entry) were weighed, with 40% of the original mass recovered. The condition of the recovered debris items varied widely; from highly melted, twisted and torn, to near pristine (Figure 2). Overall, the damage distribution of crew module debris is consistent with surrounding debris from the forward fuselage structure.

Debris recovered from the crew module experienced noticeably less aerodynamic heating than other portions of the vehicle. Primary and secondary structure elements failures occurred at high temperatures evidenced by broomstick² fractures. Five major attach points that suspend the crew module inside the forward fuselage were recovered, the port and starboard side fittings were recovered with evidence of high heating.³

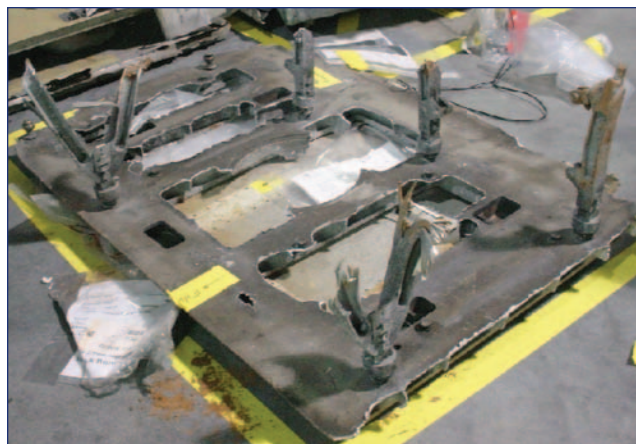
Figure 3.

Approximately 80% of the mid-deck floor was recovered. Generally, mid deck floor panel and structure components experienced heating, but not of sufficient magnitude to cause melting of metallic components (with the exception of the LiOH door (Figure 3) and a few very localized areas on two recovered structure items). Heating was however sufficient to cause significant damage to the Aeroglaze topcoat (paint) and in some cases the Koropon primer.

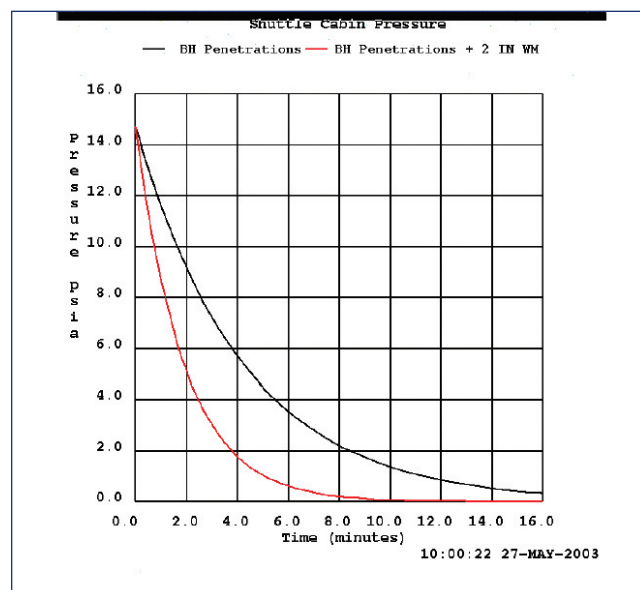
An analysis was performed to determine the time required for the cabin to depress to the altitude pressure at 200,000 feet (0.0028 psia) from a nominal 14.7 psia cabin pressure. Five (5) cases were analyzed, (a) bulkhead (BH) penetrations of 2.54 in2, (b) BH penetrations + 2" diameter hole (equivalent to eject the Waste Collector Subsystem (WCS) Commode Control Handle (CCH) ball), (c) 36" diameter hole (equivalent to the Airlock "A" hatch), (d) 36" diameter hole + BH penetrations + 2" WMC penetration, and (e) 72" diameter hole + BH penetrations + 2" diameter WMC penetration.

Figure XYZ Cabin Depressurization Cases (a) and (b).

Each case was selected to understand the range of possible depressurization rates, as a function of possible CM break-up scenario. Case (b) was selected as the WCS CCH ball was one of the furthest west CM item found. Case (c) was selected to simulated loss of the Airlock "A" hatch.

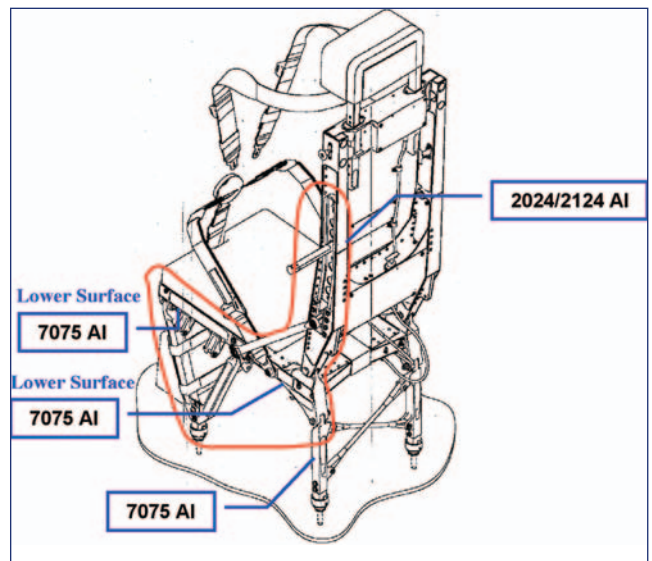
A rather large collection of seat debris items was recovered. Since the majority of the lightweight seat design is common to all seven seat locations, positive seat assignment on most of the recovered seat debris was not possible. Major differences in the magnitude of thermal exposure were identified on flight deck vs. mid deck seat locations. As with the flight deck structure, flight deck seat components were highly melted and/or deposited with splattered aluminum on all surfaces. In contrast, mid-deck seat structural components did not experience any melting at all. The mid-deck seat 6 and 7 locations (Figure 3) did however collect significant deposits of melted aluminum from the LiOH door that these two seats were attached to. This melting appears to have occurred due to the LiOH floor panel having the seats and crew still attached at the time of separation from the CM.

Mid Deck: Materials Sampling Analysis on Recovered Seat Debris Items.
